ARTHUR LUIS FERMIANO DA SILVA

UNDERSTANDING AND MODELING SOIL EROSION

Graduation Work presented to  
São Carlos School of Engineering,  
University of São Paulo for  
obtaining the title of Environmental  
Engineering

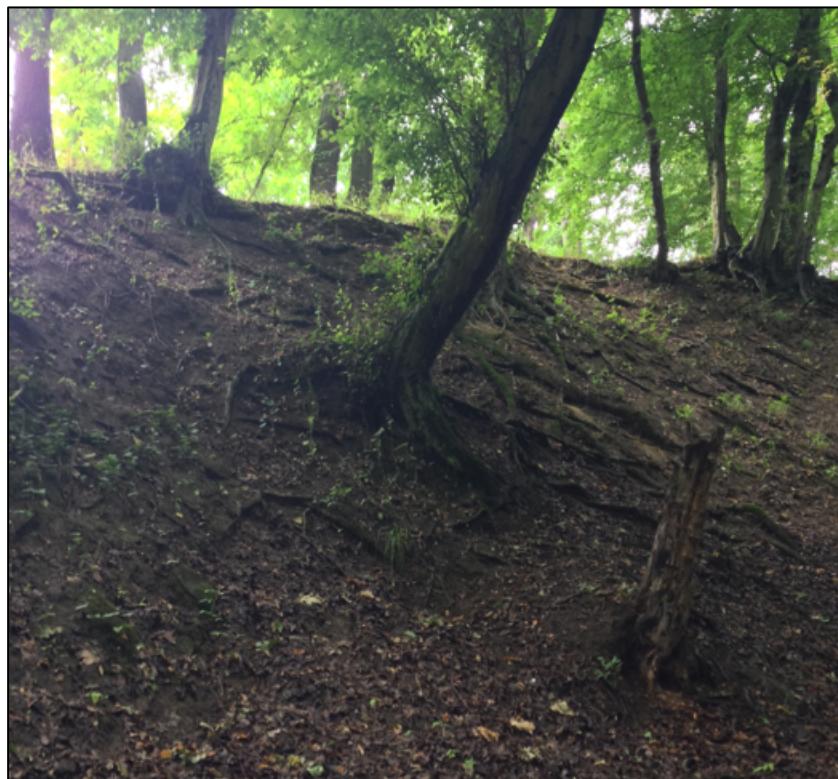
Figure 1 - Creep erosion observed by the trees. Neszmély, Hungary. Photo: Arthur Fermiano (2014)

Slow mass movement occurs as creeps or solifluction. Creep is the slow and continuous downhill movement of the shallow layers of the soil or decomposed rock above the deeper layers, and it can be observed by the direction of the trees (Figure 1). Solifluction is the flowage of water-saturated soil in areas typically underlain by frozen ground (CAMARGO, 2012).

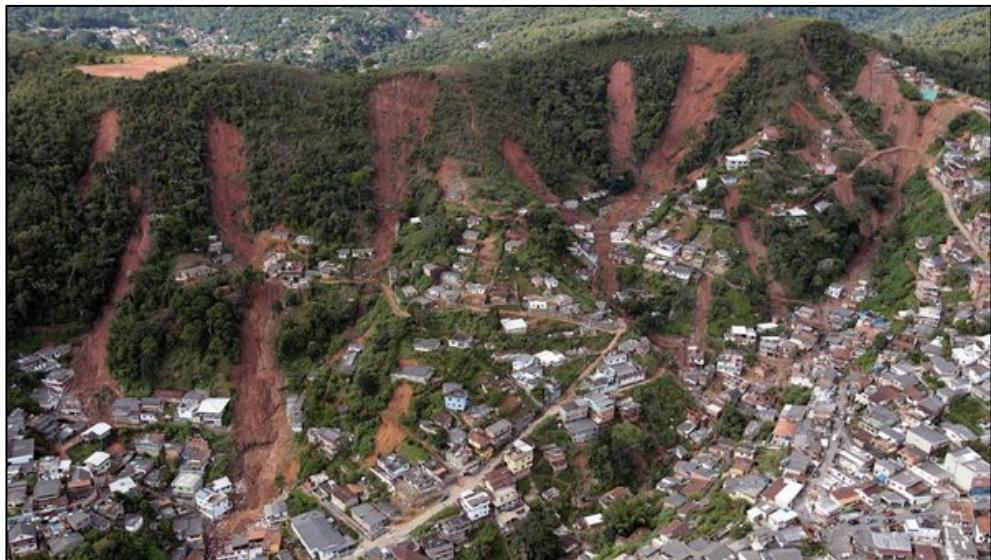
Figure 2 - Landslide in Teresópolis after heavy rain, Rio de Janeiro, Brazil. Photo: Antonio Lacerda (2011)

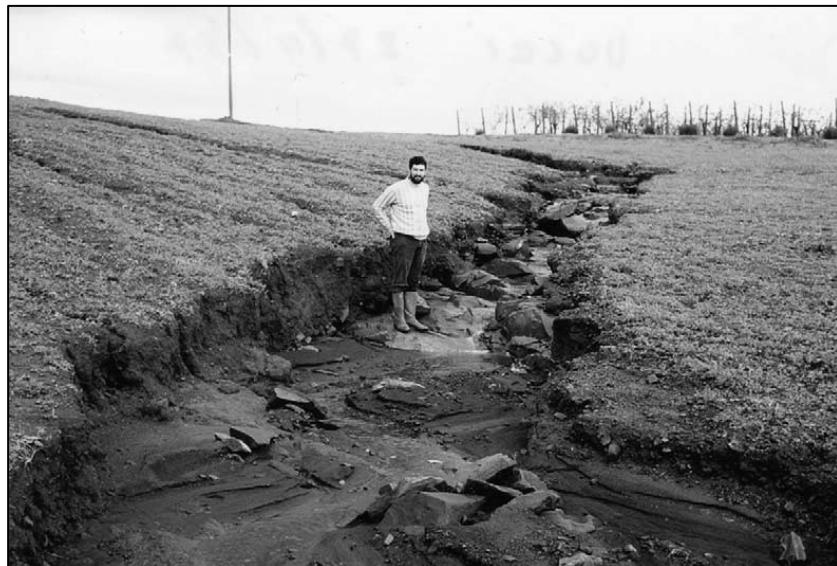
Figure 3 - Ephemeral gully erosion in Vulci, central Italy. hard unweathered bedrock at a depth of ca. 90 cm (POESEN et al., 2003).

Sandy soil tends to be more susceptible to erosion, as shown in the Figures 3 and 4 (POESEN et al., 2003). On the other hand, soil crusting can delay the initiation of gullies due to their stronger shear strength as compared to non-crusted soils (VALENTIN; POESEN; LI, 2005).

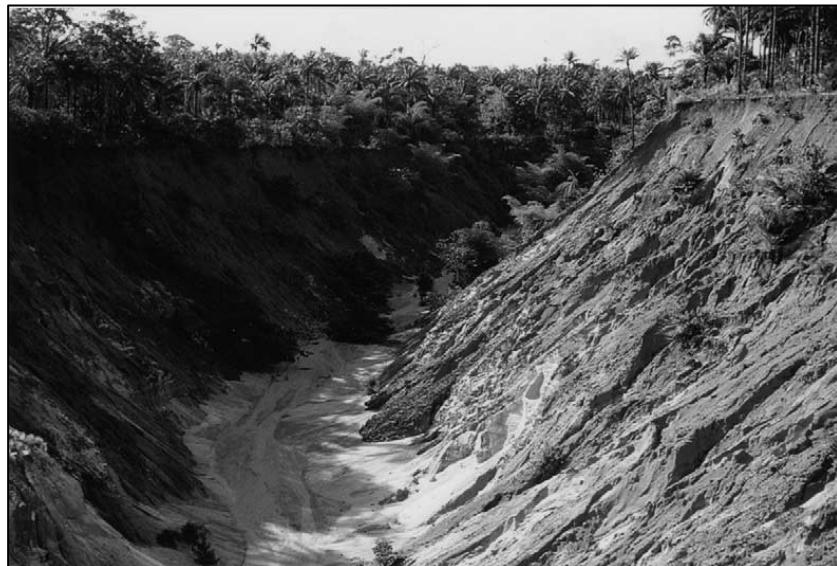
Figure 4 - Large (ca. 15–20 m deep and ca. 30–40 m wide) permanent gully which developed in unconsolidated Tertiary sandy sediments, Owerri, South Nigeria (April 1988) (POESEN et al., 2003).

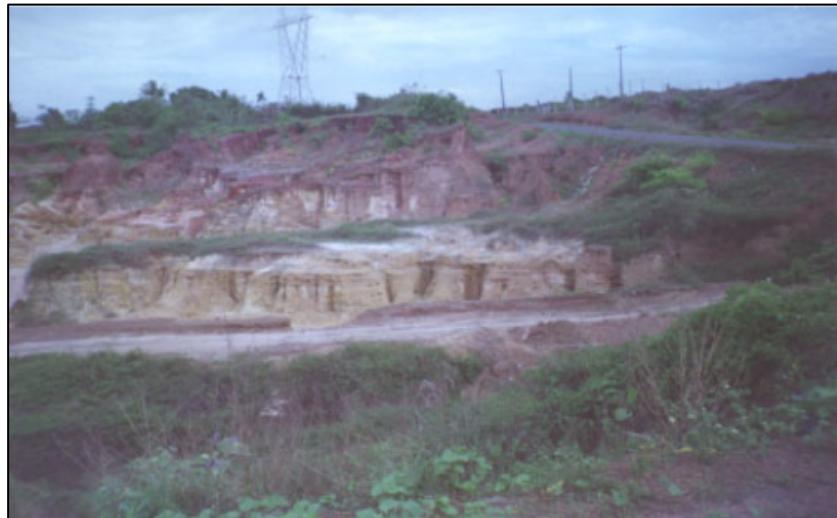
Figure 6 - Voçoroca under monitoring in urban areas. São Luís city (Brazil). The head has retreated 1,5 m towards the transmission energy tower in four months (GUERRA et al., 2004).

Guerra et al. (2004) identified 17 voçorocas, monitoring 7 of them. Even within a short period (eleven month) some of the studied voçorocas showed rapid retreat with more than one meter in some cases (Figure 5). The authors observed rill formations especially on the head of the voçorocas where the water is flowing towards the voçorocas enhancing erosional processes. Although the monitored period was short, they also observed that the gullyling process was more intense where land use and management tend to disturb the environment, especially where the vegetation cover has been completed cut down (Figures 6 and 7).

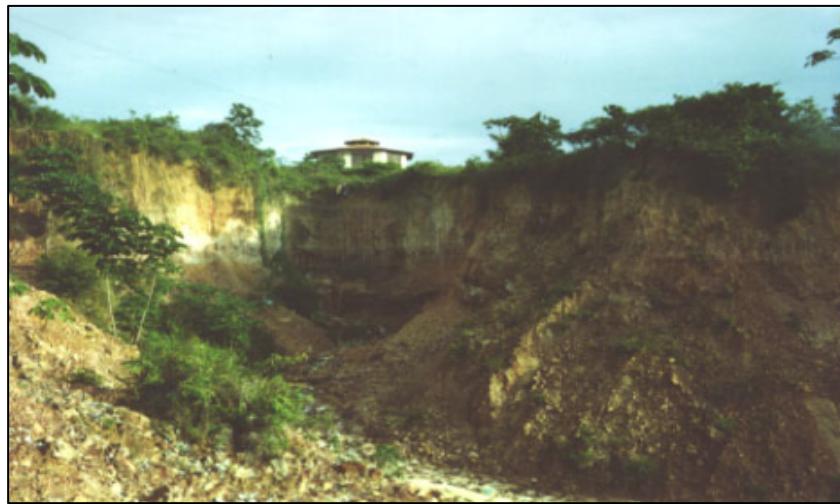
Figure 7 - Voçoroca under monitoring in urban areas. São Luís city (Brazil). The head is retreating towards the house, which is at a high risk of collapsing inside the hole (GUERRA et al., 2004).

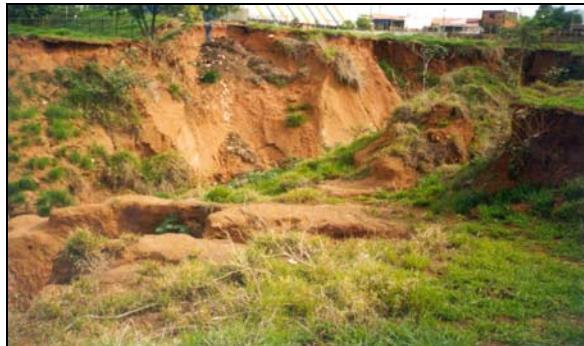
Figure 12 - Voçoroca besides occupied houses. São Carlos City (Brazil) (PEDRO; LORANDI, 2004)

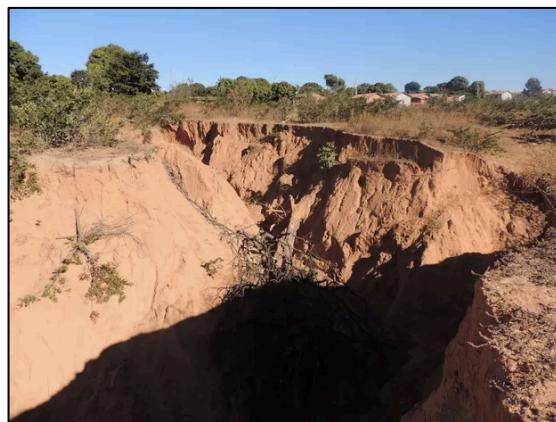
Figure 13 - Voçoroca developing towards houses, Brasília de Minas (Brazil). Photo: Maicon Rodrigues (2014)

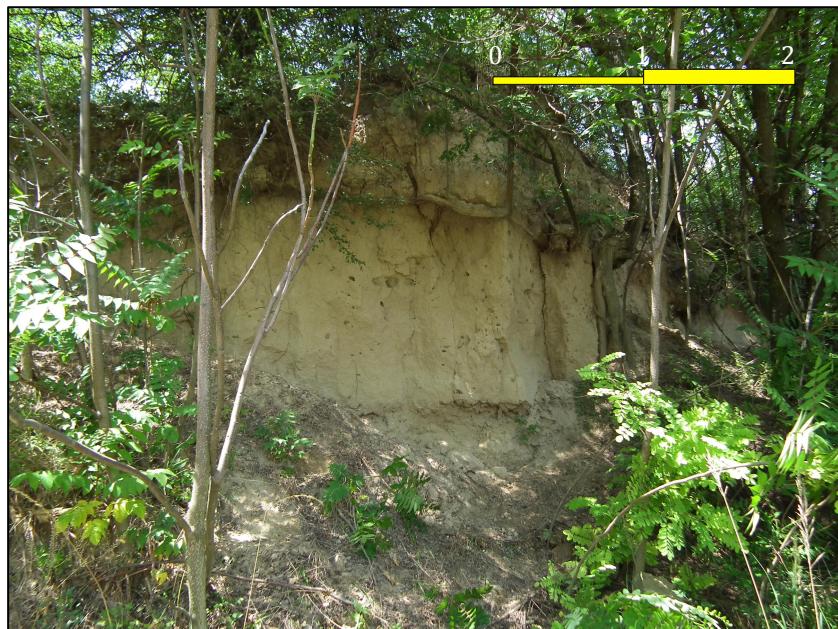
Figure 15 - Studied object: loess wall. Photo: Andrea Raveloson (2014)

One of the studied objects was in K  pite Hill, a loess wall formed either by erosional processes or by human interference (mining for using sand in the civil construction nearby). The area is visually suffering erosional process (exposed soil), but due to the presence of dense vegetation around to hold the material, it is on its way to stabilize, as it can be seen in the Figure 15.

The exposed wall has approximately 6 m width and 3 m height. The lower part is made of whitish loess, and the upper part is hold by the vegetation with plant roots emerging from the darker soil. The higher parcel of organic matter can explain the color of the upper part. For this area we chose to use two devices: the iPhone 5 and the semi professional camera FUJIFILM.

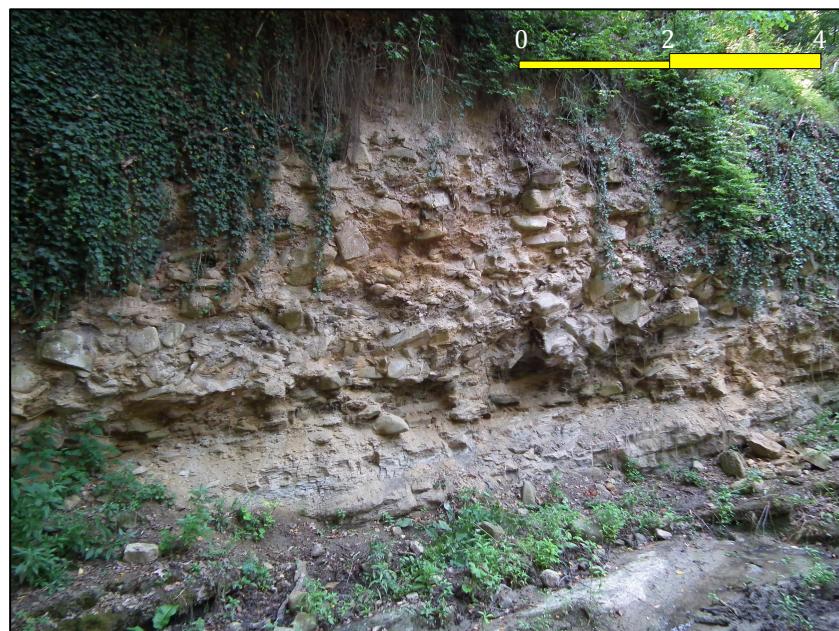
Figure 19 - Studied object: Cretaceous Conglomerate. Photo: Andrea Raveloson (2014)

Another studied object was in Ivánhalála valley, a conglomerate with sandstone immersed in a sandy material, which enhances the susceptibility to erosion. The basement of this conglomerate is a Cretaceous sandstone layer in the lower part of the outcrop (Figure 19).

The exposed area has approximately 8 m width and 4 m height. It is part of a large vegetated and apparently stable wall that follows a stream curse. We used three devices to capture the photos: the iPhone 5 and the two semi professional camera (FUJIFILM and CANON).

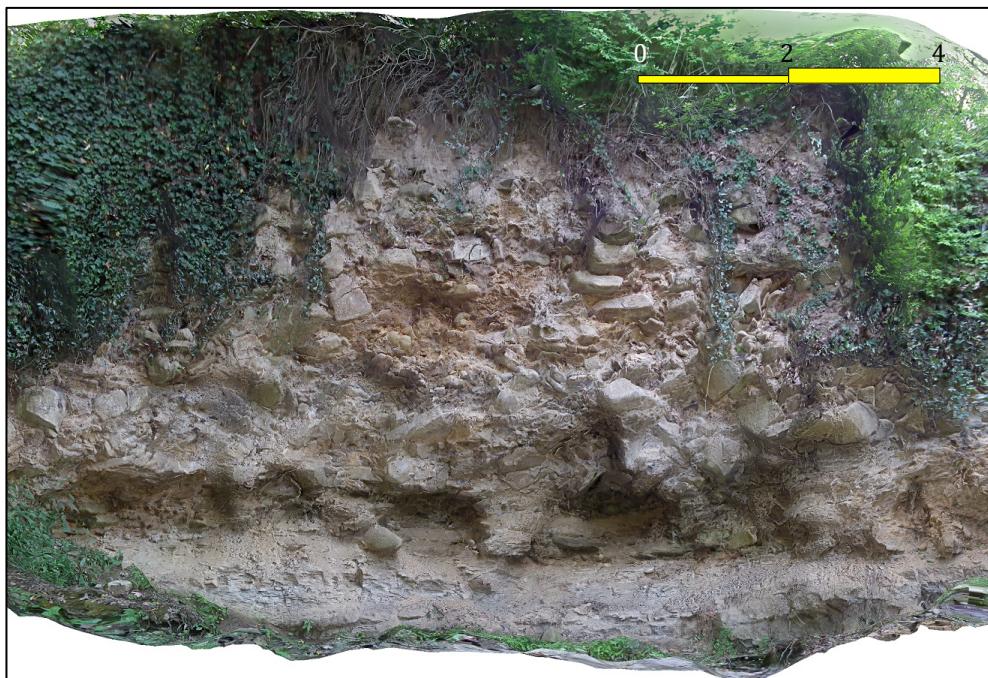
Figure 21 - 3D model from conglomerate. Device used: FUJIFILM.

The Figures 20, 21 and 22 show the models done with the use of the iPhone, the FUJIFILM camera and the CANON camera, respectively. The three models resulted in reasonably good models with low mean error generated during the photo alignment. The model where the FUJIFILM camera was used showed more details and a slightly better performance on the shape in accordance with the texture, despite of resulting a maximum error of 1.176 pixel (the highest among the three models). The model which resulted in the lowest maximum error (0.916 pixel) was the one that the CANON camera was used.

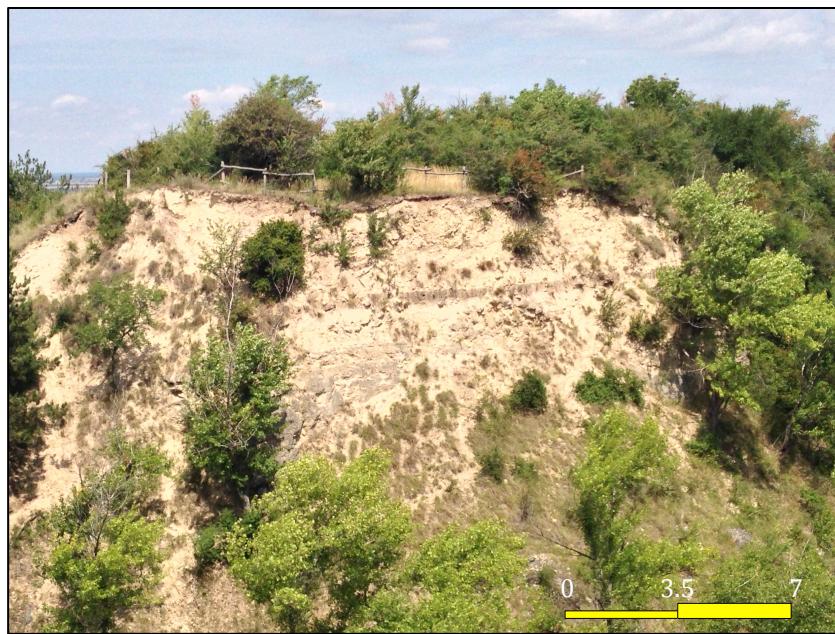
Figure 23 - Studied object: sandstone outcrop. Photo: Arthur Fermiano (2014)

The third studied area was a sandstone outcrop with limestone layer, as can be seen in the Figure 23. The area is part of an old Roman mine, and the exposed part has approximately 15 m width and 10 m height in a very steep wall. Even being an ancient mine, the area still shows ongoing erosional processes, once most of its

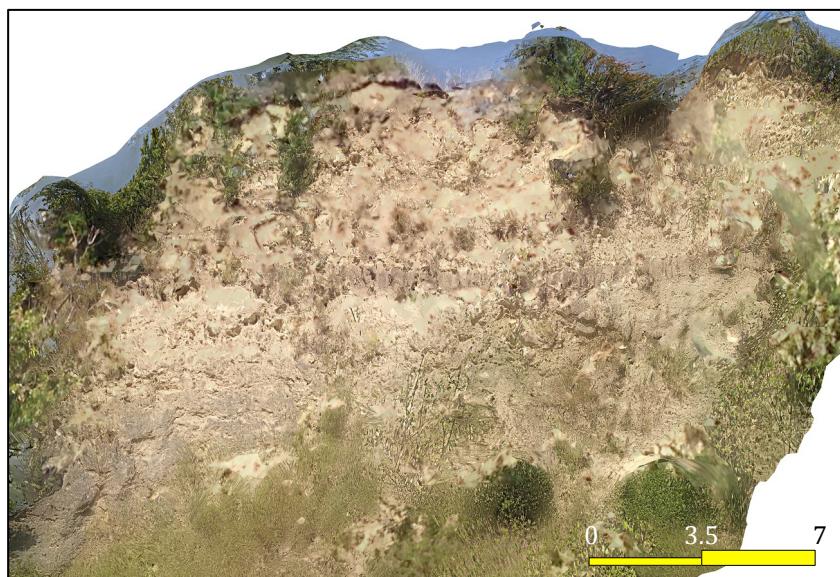
Figure 24 - 3D model of sandstone outcrop. Device used: iPhone.

Figure 24 shows that the model using the iPhone did not result well, but at least the limestone layer and other features of the relief can be seen. On the other hand, the model using the camera SONY did not work at all (Figure 25), showing irregularities in the 3D model with unrecognized surfaces and a cluttered texture.
